Ground penetrating radar surveys at Wardleys

Site location: NGR SD 36561 42842

Date of survey: 8 March 2024.

Objectives of survey: to determine subsurface features that may be associated with former warehouse building at the site.

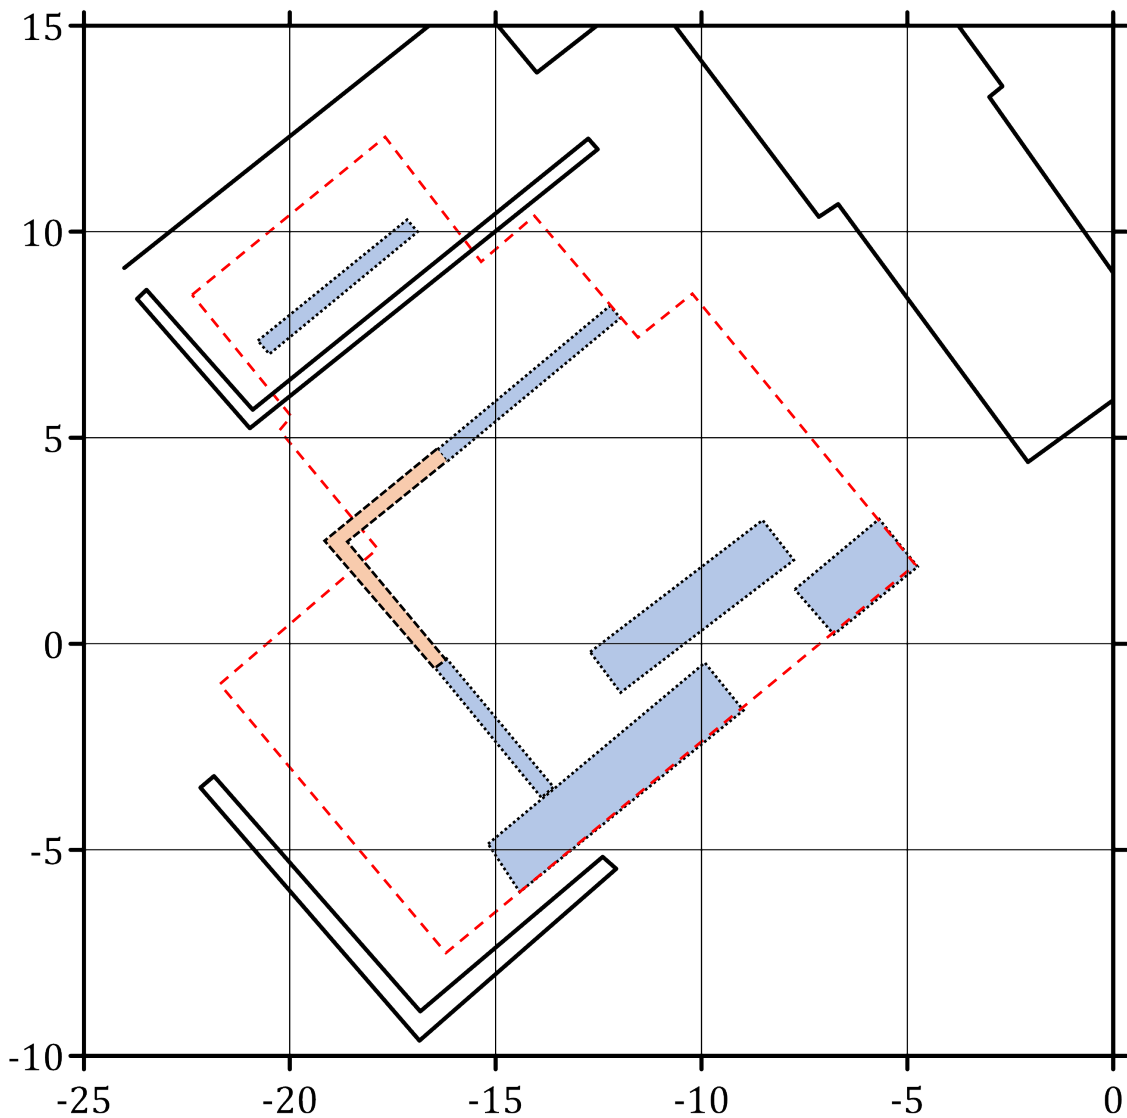
Depth: 0.2 – 0.5m

All of the features in plots A,B & C appear to be parallel or orthogonal, except for the approximately north-south anomaly seen at intermediate depths in plots A and B. Is this a more contemporary feature?

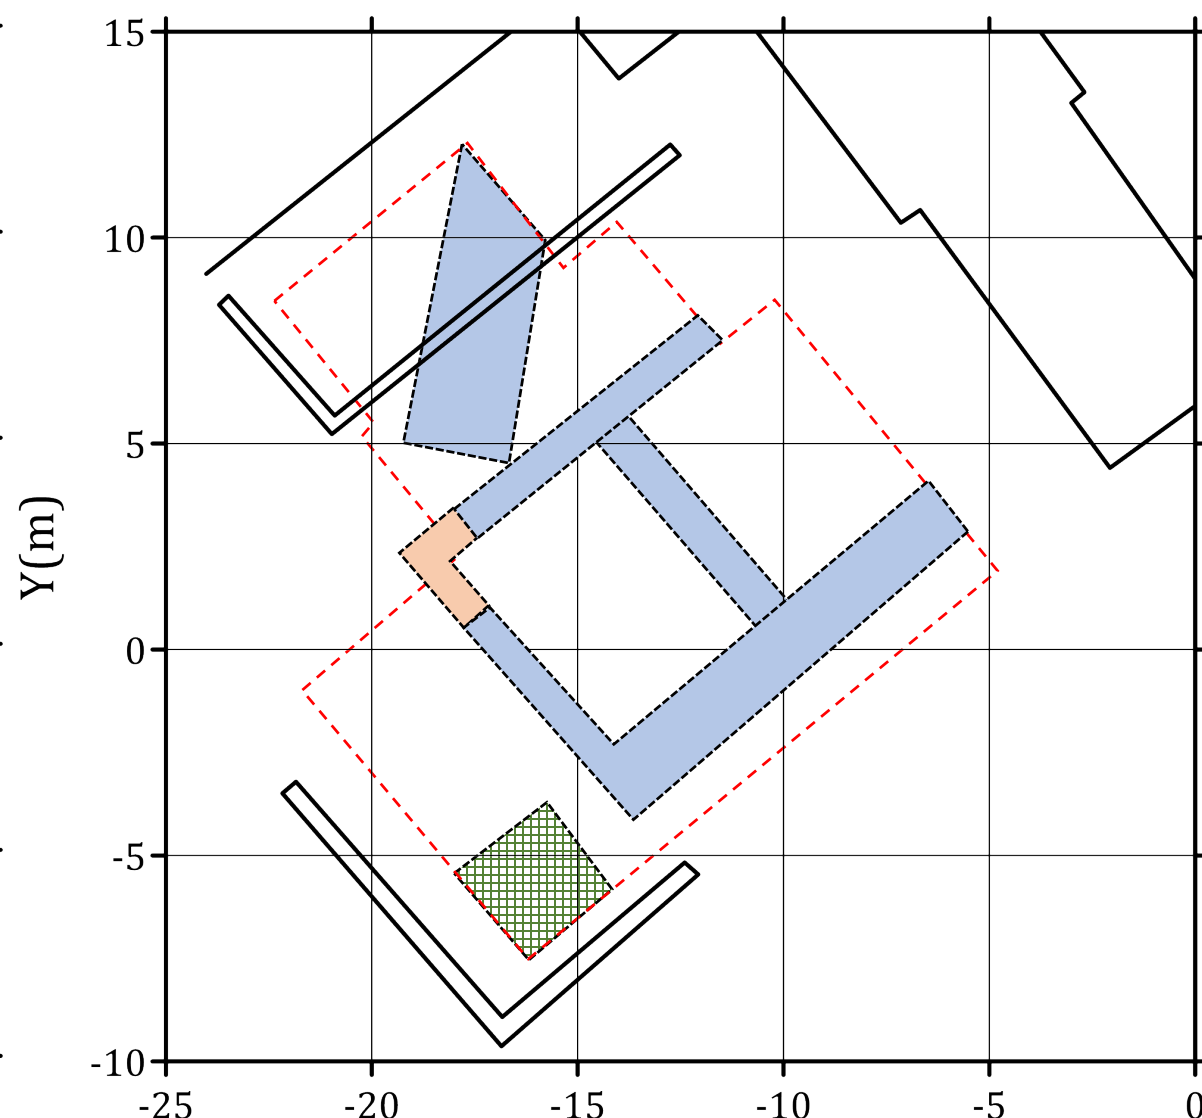
Depth: 0.5 – 0.9m

It is not clear what the cause of the attenuated patch in the south of plot C (i.e. near the outer wall). It looks too angular to be natural. What could be the cause? It appears to be of high electrical conductivity, e.g. saline or fine textured material.

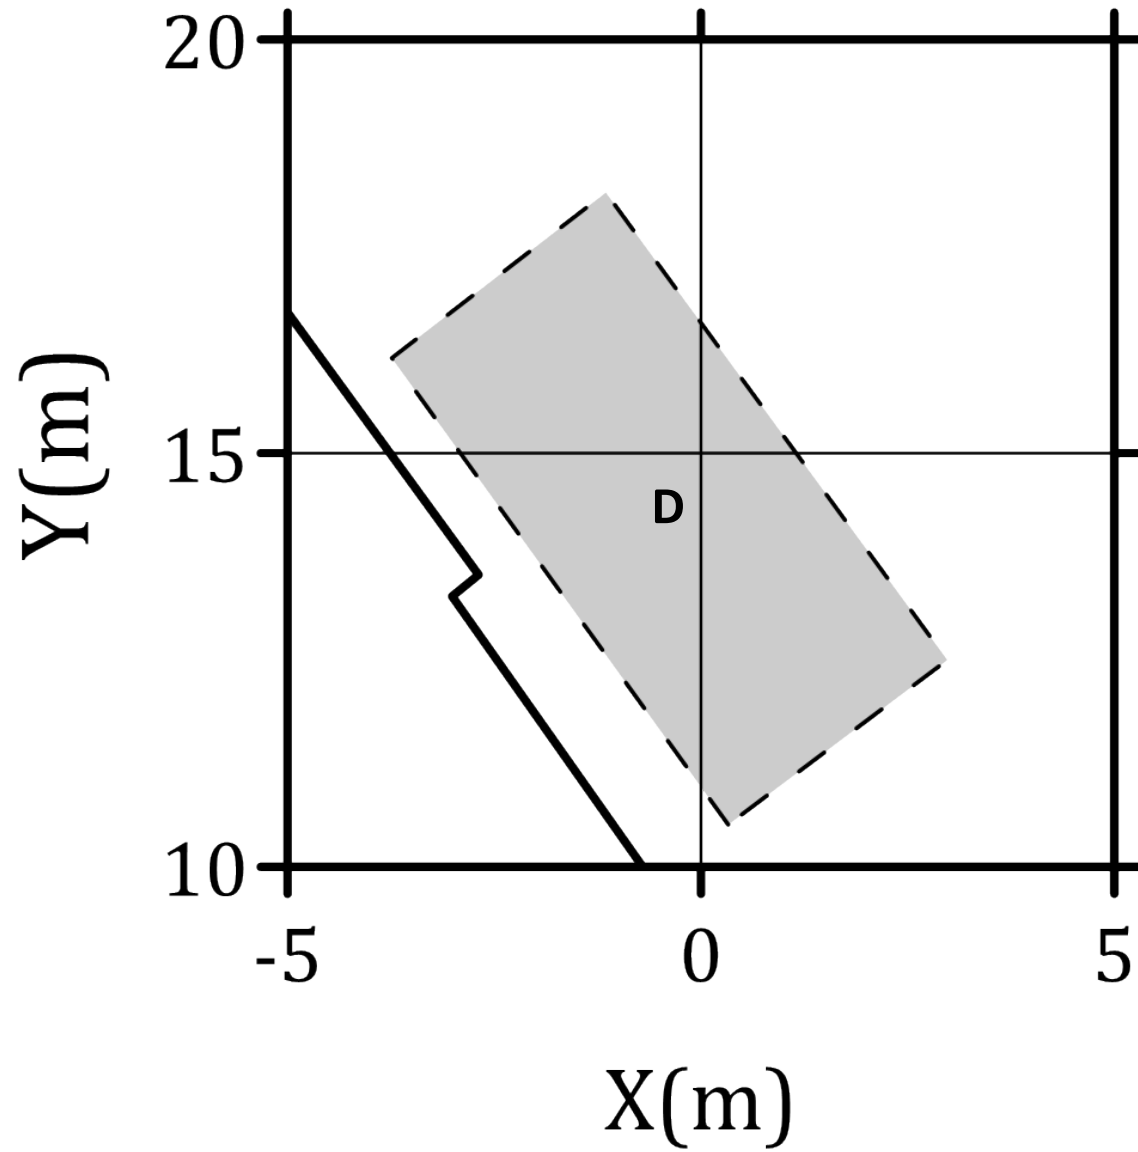
GPR results for
plot D

No significant linear features seen in plot D except perhaps at 0.2m
