# 46 St Michael's Road, Kirkham, Lancashire

## Archaeological Watching Brief

**Oxford Archaeology North**

December 2010

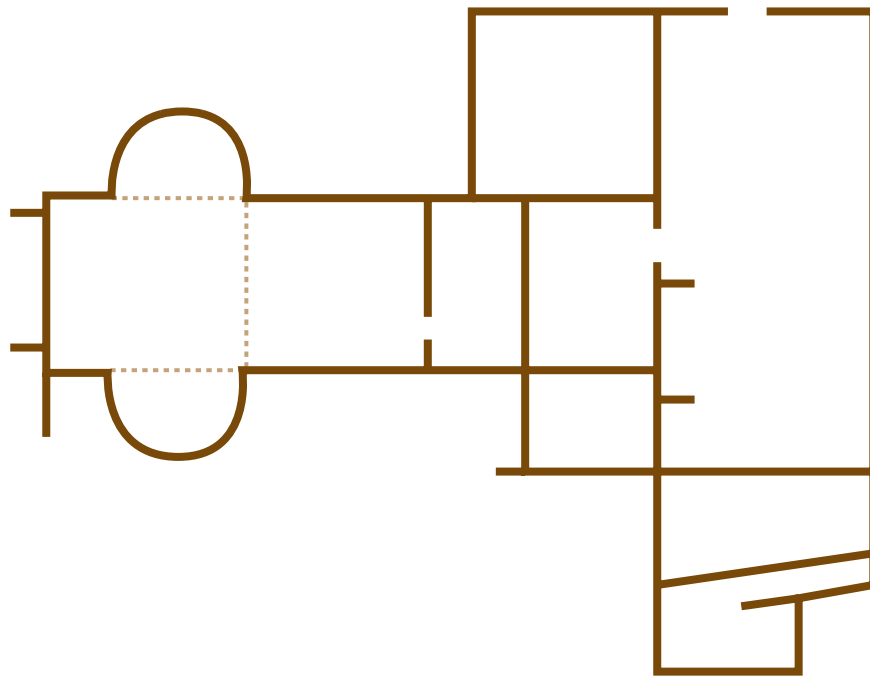
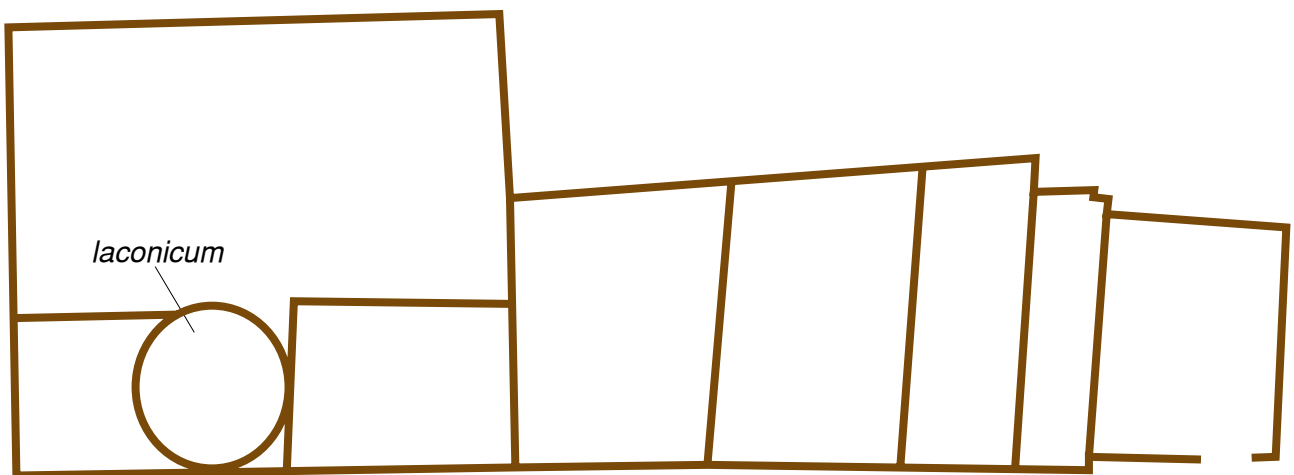
Figure 4: Apsidal rooms or alcoves in the fort baths at Great Chesters, on Hadrian's Wall, and the circular *laconicum* in the late first-century baths at Catterick, North Yorkshire

**Great Chesters**  
Mid-second century AD

**Catterick**  
Late-first century AD

- 3.1.6 On the evidence available, it is not possible to tell whether the Kirkham structure may have formed part of a *laconicum* ('detached' or otherwise) or an apsidal room. At possibly *c* 3m in diameter, internally, it would have been considerably smaller than the *laconicum* in the Flavian baths at Catterick (*c*

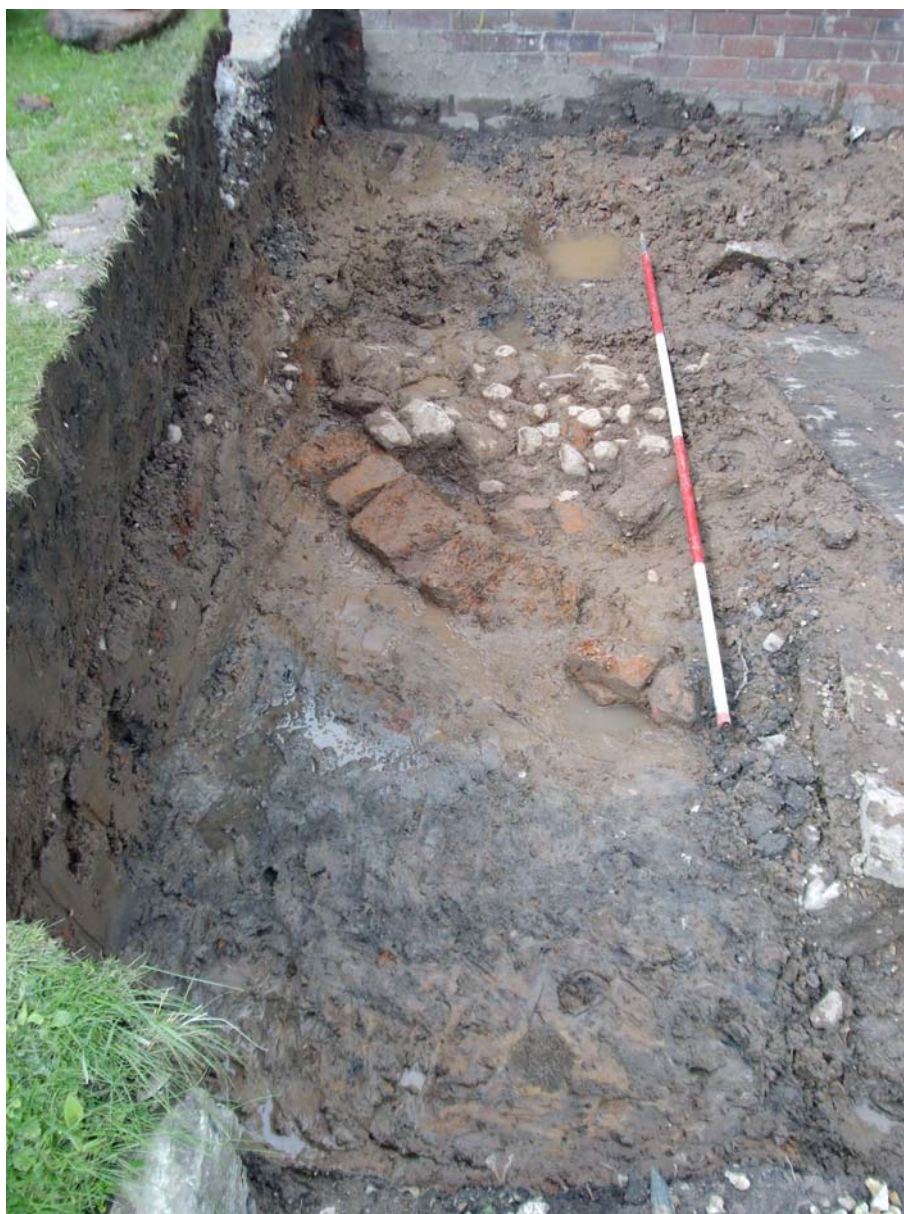
Plate 1: Trench 1, looking north: curving brick and sandstone wall **117/129**, enclosing possible late cobble surface **118**

- 2.1.2 **The masonry structure:** the most significant discovery, located at the northern end of Trench 1, was that of a stone- and brick-built circular or apsidal structure of Roman date, furnished with an under-floor heating system (Fig 3). Only part of the south-western wall was seen, together with a small area of the interior, but if the curve of the inner wall face is projected northwards, it is possible to estimate that the structure may have had an internal diameter (or a north to south dimension, depending on whether it was a circular or apsidal feature) of *c* 2.9-3m. It may be significant that this measurement corresponds to ten Roman feet (*pedes Monetales*), taking the *pes Monetalis* as equalling 0.29617m (Walthew 2005, 273). The observed wall (117) was 1.3m wide, and comprised two surviving courses of large, fired clay bricks (Fig 3; Plate 1), standing to a maximum height of 0.3m within the area investigated. These were seemingly mortar-bonded, and had been laid above a basal course of roughly dressed red sandstone blocks (129). A deposit of almost pure pink-brown sand (133), seen immediately outside the wall, appeared to fill a curving cut, *c* 0.35m beyond the wall (Fig 3; Plate 2), that is most likely to represent the edge of the wall construction trench. Spatial evidence strongly suggests that this cut through ditch 119 (Section 2.1.1).

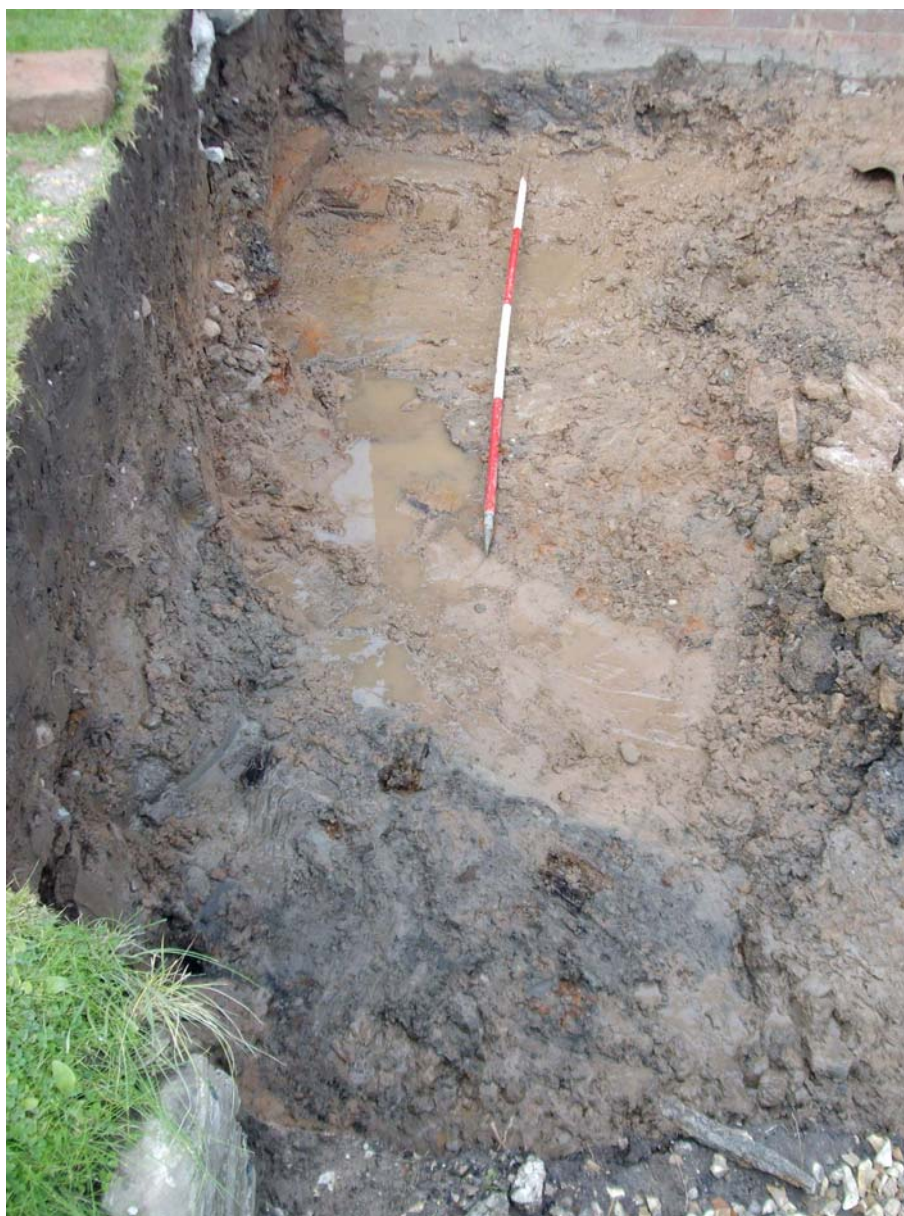
Plate 2: Trench 1, looking north, showing the pale fill (*I33*) of the construction trench for wall *117/129*, seemingly cutting the dark grey fill (*I20*) of ditch *119*. Wooden post/stakes *I34*, *I35*, *I36*, *I37* and *I38* are also visible

- 2.1.1 **The early ditch:** the earliest feature on the western part of the site was recorded at the southern end of Trench 1, where part of what may have been a ditch (119), at least 1.25m wide and filled with an organic, charcoal-rich mid-dark grey-brown soil (120; not illustrated), was found (Fig 3). Its southern edge extended north-east to south-west across the full width of the area investigated. To the north it had been destroyed by the construction trench for a later masonry structure (Section 2.1.2). Four preserved wooden posts or stakes (135, 136, 137, 138) were found within this feature and a fifth (134) lay immediately outside its southern edge (Fig 3); it is unclear, however, whether any of these were directly associated with 119, or were later.

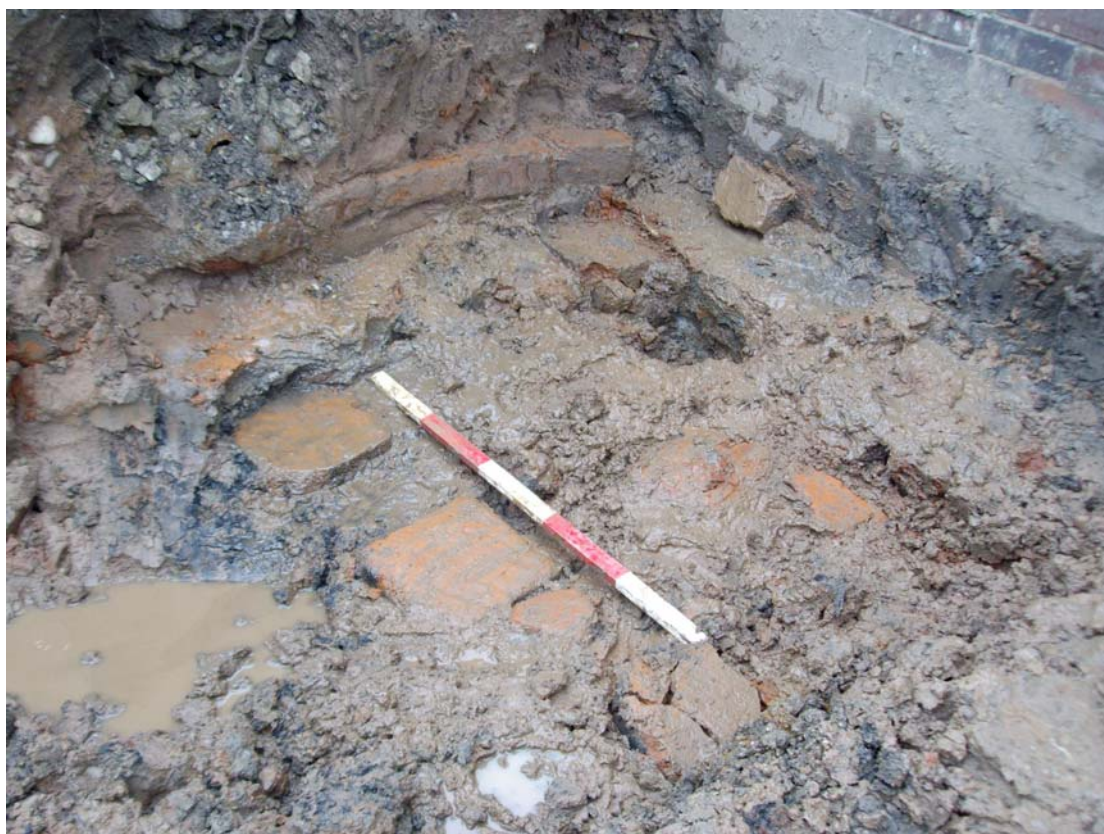
Plate 3: Trench 1, looking north-west: ceramic *pilae* 126, with the inner face of wall 117/129 to the rear

- 2.1.3 That the interior of the structure had been heated was clearly indicated by the presence of tile-built hypocaust stacks (*pilae*). Four complete examples (126) and fragments of what may have been a fifth, lay within the site (Fig 3; Plate 3); all survived to only a single course, and were composed of large, square tiles, measuring approximately 280 x 270 x 65mm. Overlying the geological clay at the base of the hypocaust system, and extending around the extant *pilae*, was a black deposit (125; not illustrated), up to 0.37m thick and composed almost entirely of charcoal; this presumably derived from the firing of the heating system, though no trace of a fire-pit or stoke hole was found within the area investigated.

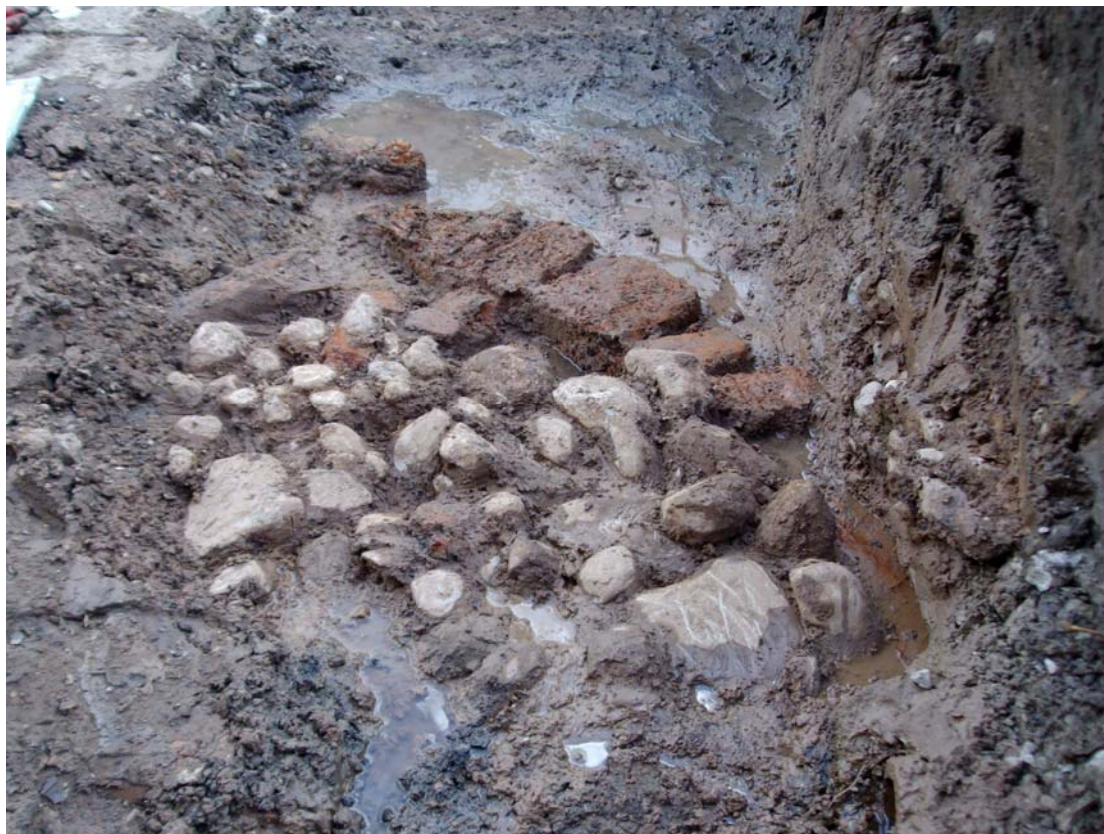
Plate 4: Trench 1, looking south: possible late surface 118, enclosed by wall 117/129

were in turn overlain by a deposit of cobbles and sandstone rubble (118; Fig 3; Plate 4). This had the appearance of a deliberately laid surface, rather than demolition debris, and clearly respected the position of the excavated wall of the structure. If correctly interpreted, this surface was clearly laid down after the heating system had gone out of use and been dismantled, but before the structure itself was demolished.

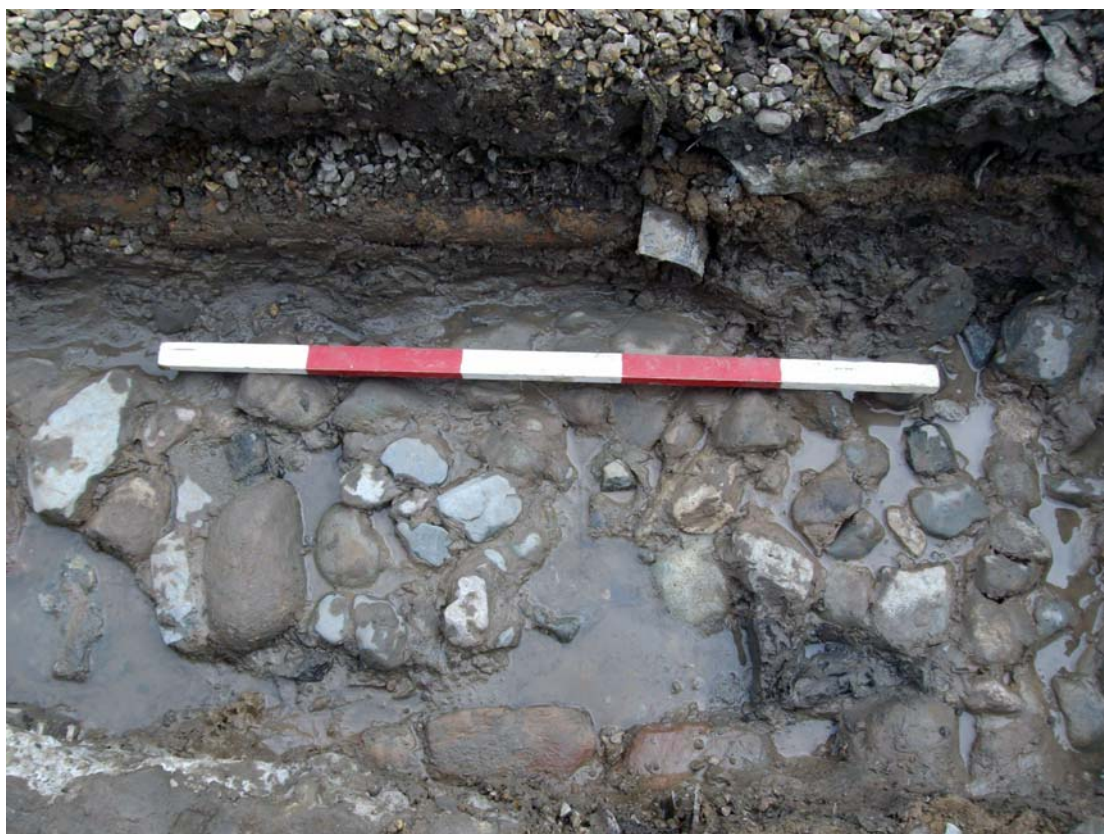
Plate 5: Trench 2, looking south-east: cobble surface **104**, bounded on the north by sandstone wall/setting **105**

- 2.2.1 A quite complex series of Roman features and deposits was recorded in a limited area within Trench 2, principally at the south-western end of the trench, at its junction with Trench 1. The earliest recorded deposit was a layer of fine, grey-brown sand, possibly a natural accumulation. This was overlain by a mid-dark grey-brown organic soil (111; Fig 3), up to 0.24m thick, containing small fragments of preserved, waterlogged wood. Above this was a well-laid surface of water-worn cobbles, pebbles and sandstone fragments (104), 0.15m thick, recorded in a limited area measuring *c* 2 x 0.75m (Fig 3; Plate 5). A setting of at least three large sandstone slabs (105) on the north side of this could not be adequately characterised, since they lay largely outside the area investigated (Fig 3; Plate 5). A single, roughly squared sandstone slab (106) was also located on the north-eastern periphery of surface 104, *c* 1m west of 105. Although 105, 106 and surface 104 were located little more than 0.3m south of the southern edge of ditch 119 in Trench 1 (Section 2.1.1), no stratigraphic relationship could be established between these deposits and that feature.
